In This Issue...Design Errors Can Cost You Money

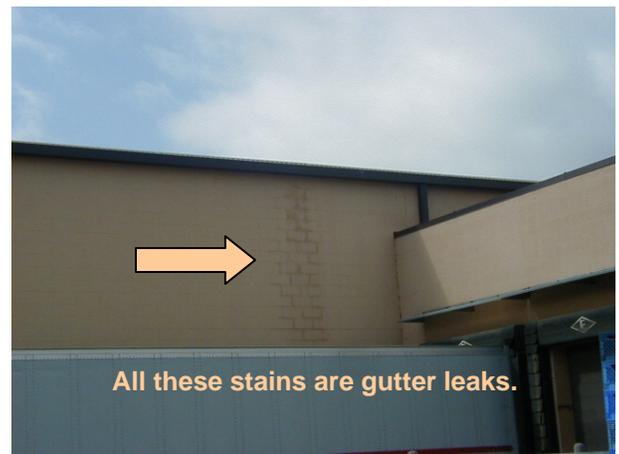
Whereas the specific problem in the first photo is not common, the photo below illustrates a very common problem. The gutter on the back of this building is leaking. The arrow points to water stains on the wall. It was actually leaking before the project was ever finished. Again this is a design related problem. The rear edge of this building is approximately 175 feet long and the gutter was assembled in one long piece. WRONG! Metal moves. The gutter should have been fabricated in lengths not to exceed about 40 feet in length and separated with expansion joint covers. The joints are pulling themselves apart from contraction and expansion!

These leaks are not just aesthetic issues. If you would go inside the building you would see that some of this water is now penetrating the wall (after about 8 years) and creating problems inside the building. Not only does the gutter need to be reworked, but the rear of the

building is going to have to be repaired and repainted very prematurely. This problem is easily avoidable at the time of construction at very low additional cost, if any. The proper details are actually very standard and widely known, but gutter problems such as this are very common on many buildings we see.
