## In This Issue...Gutters

The most common problem with gutter systems is leaking splices.

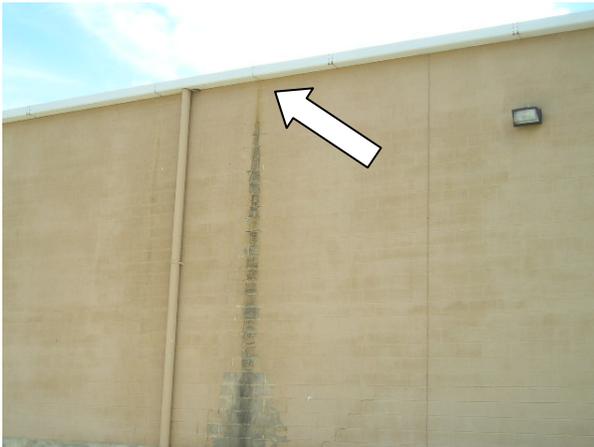
As can be clearly seen in the photo above, the gutter leak (which is at a splice between two adjacent sections of gutter) has stained the wall. You will notice toward the bottom that the paint is completely gone from the wall. Paint is not designed to be constantly wet and when that happens it fails more quickly. Failure to do a repair costing a few hundred dollars to the splices will create the need to repaint the walls prematurely for thousands of dollars (as well as still having to repair the gutter splices.)

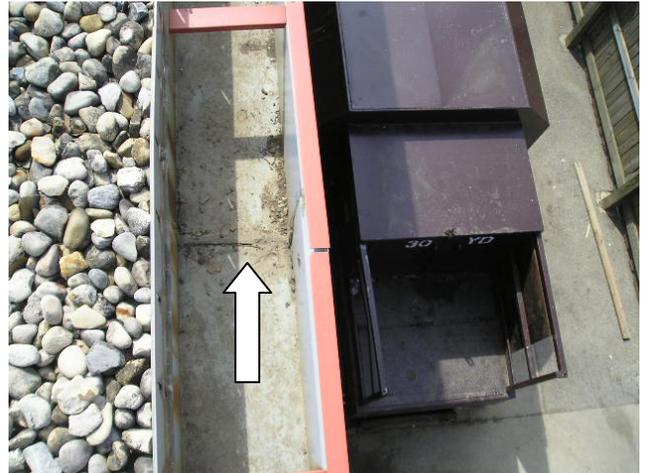
The photo above shows a typical gutter splice where sealant was applied between the adjacent pieces as the gutter was installed. This just doesn't hold up. The next photo shows a splice made with an elastomeric (rubberized) compound, specifically designed

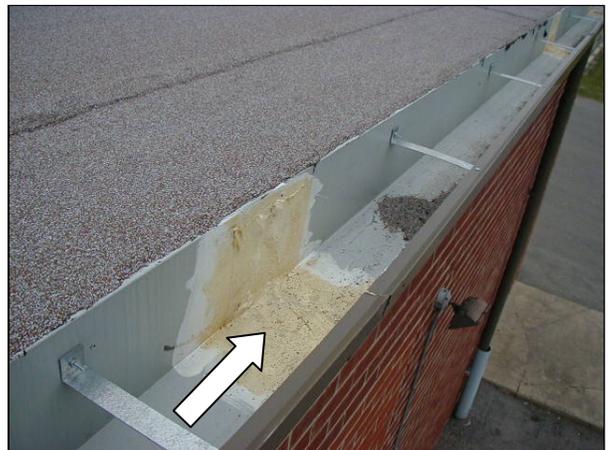
to be used in a gutter where there is often prolonged periods of standing water. Each splice is reinforced with a piece of mesh embedded in the coating. So, as the gutter moves the splice can flex with it. This is the right way to seal a gutter and is much cheaper to do in the long run.
