In This Issue...HVAC Units and “Roof Leaks” – Part 1

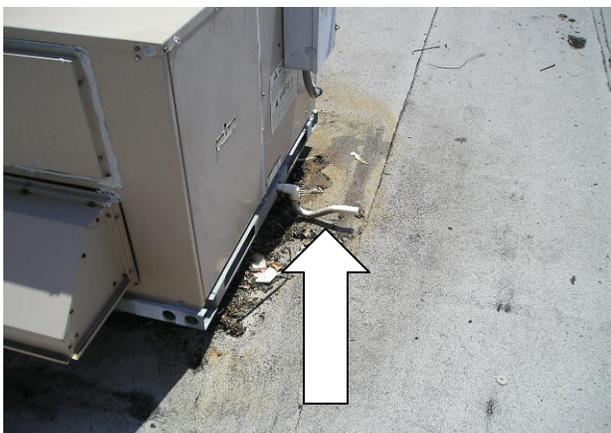
Most curb mounted HVAC units dump their condensation through a pipe on the side of the unit. These outlets require a “P-trap” to be installed to insure proper operation of the drain. Without a trap it is possible that the condensate drain will not function and the condensate pan will overflow into the building below causing what appears to be a “roof leak”. Often this drain problem is not constant, so the unit drains properly sometimes and sometimes not. This makes finding the “roof leak”, which doesn’t exist at all, much more difficult isolate. See the arrow in the photo below for a proper P-Trap.

The “staining” shown in the arrow (and also clearly visible in the first photo as well) is actually a thinning of the granules because the roof has been continuously wet over prolonged periods of time. The water coming out of the P-trap should be piped all the way to the drain. This roof now needs restorative repairs which would otherwise not be required had the condensate been handled properly.
