# Roof/Top/Topics

In This Issue...Design Issues – More on Walls – Last Part, For Now.

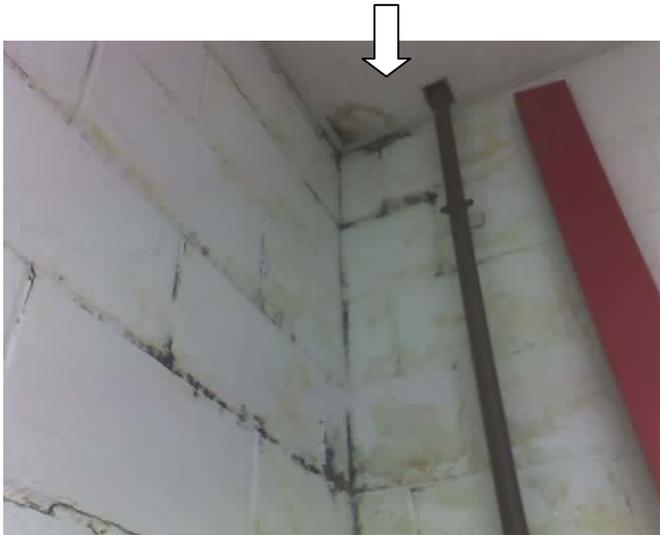
A client recently called because a “leaking roof” was causing mold growth at the rear of one of their tenant’s spaces. The photo below clearly shows mold growing and the arrow points to a stain on the ceiling tile that is also water damaged.

The wall is a mess. The client was horrified and wanted to know why we had projected a life expectancy for this roof of another 2-4 years, or more.

You can also note that most of the mold and intense discoloration is on the mortar joints. Mortar is more porous than the actual masonry units so it will tend to hold more water.

The problems seen on the inside of this wall could be roof related and the typical building owner, like our client, assumed this was roofing related. Dispatching a roofer to fix this is a complete waste of time. The next time you have “leaks” at an outside wall, before you call the roofer, be sure to check the outside of the building to make sure your walls don’t have cracks like these! Note also in the last photo the rust on top of the wall. This will be explored in the next newsletter.

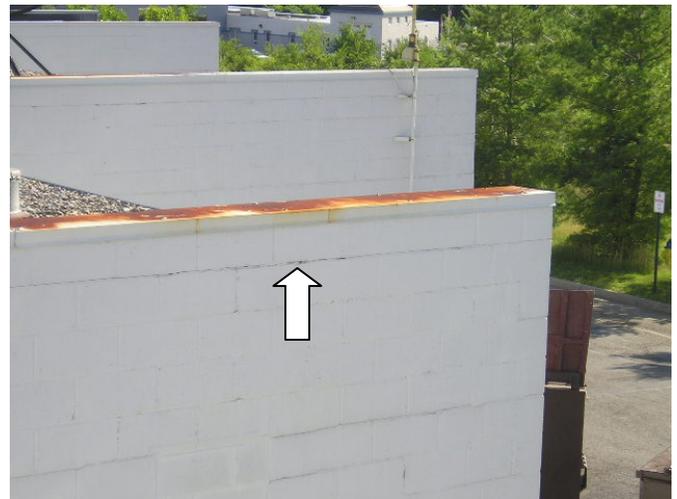
We referred the client to the following photo in the next column, which was part of the report they had received from us for this shopping center. The arrow in this photo shows a dark horizontal line running below the top of the coping. This is where the top course of block sits and the line is darker because there is actually a crack in the mortar joint. This is where the water has been entering. (There is no corresponding photo on the topside of the roof, because there wasn’t anything wrong on

top to report!) The roof is not leaking and these leaks are definitely not roof related.

The crack in the wall is located almost 24” above roof height. The ceiling shown in the first photo is located below the roofline and below the steel bar joists that support it. So the ceiling is perhaps as much as 48” or more below the crack on the outside wall. It takes a lot of water to soak a wall so completely that it starts dripping out the back side and staining a
