In This Issue...Design Issues – More on Walls

This article is the second in a series dealing with waterproofing issues (roofing and otherwise) related to walls.

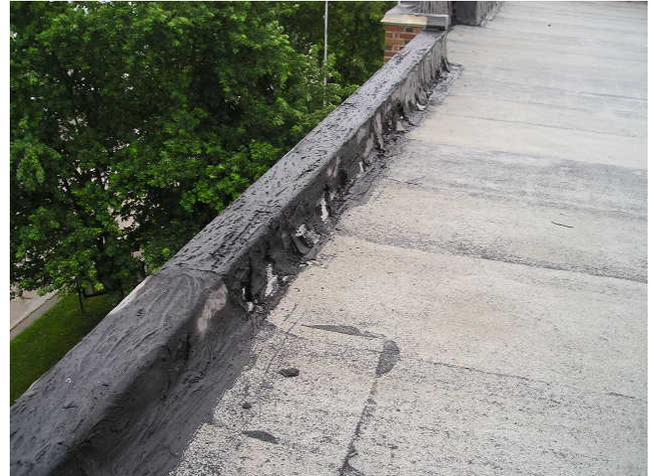
In the upper photo a portion of a parapet wall has been repaired multiple times, but never repaired correctly. Water can easily slide inside the wall flashings and soak the wall. The results of prolonged soakings coupled with freeze/thaw cycles leads to what you see in the other two photos.

Last month we suggested that all perimeter parapet walls should be encapsulated or “wrapped” whenever possible. Failure to maintain wall flashings will also eventually damage walls. Further, when repairs are attempted they need to be done properly.

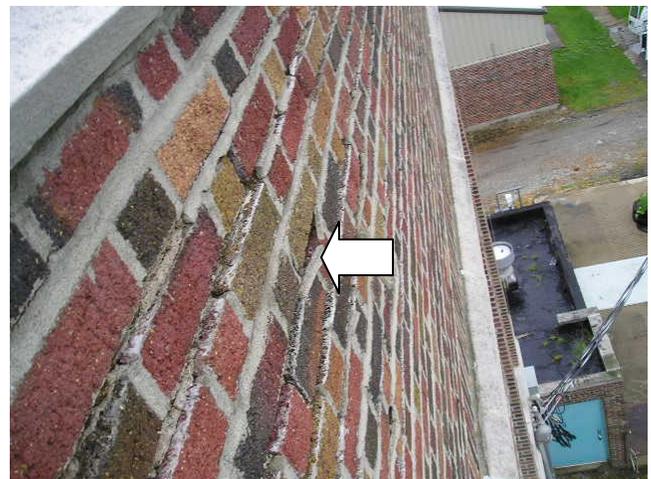
In the middle photo, which was taken by leaning over the wall in the previous photo, areas of mortar are missing entirely. The arrow points to a section of mortar that has failed, is popping out and will soon fall.

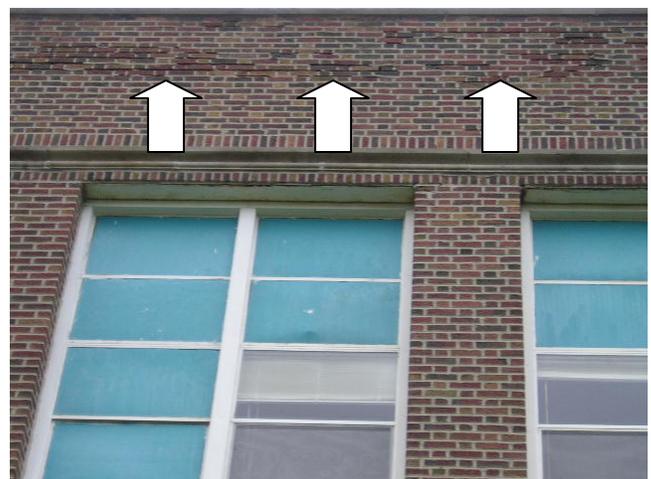
In the last photo, taken from ground level looking up, large areas of mortar are clearly seen as missing. The portions of the wall that are obviously failing are all located above the roof elevation. The portions below the arrows are not failing (yet) because they are below the roofline and are in areas that receive some heat. The areas above the roofline are failing faster because they have no protection from freezing. These masonry walls will probably have to be completely rebuilt above the roofline. The cost of these repairs will far exceed the cost of properly performed repairs.
