In This Issue...Design Issues – Wrap Those Walls

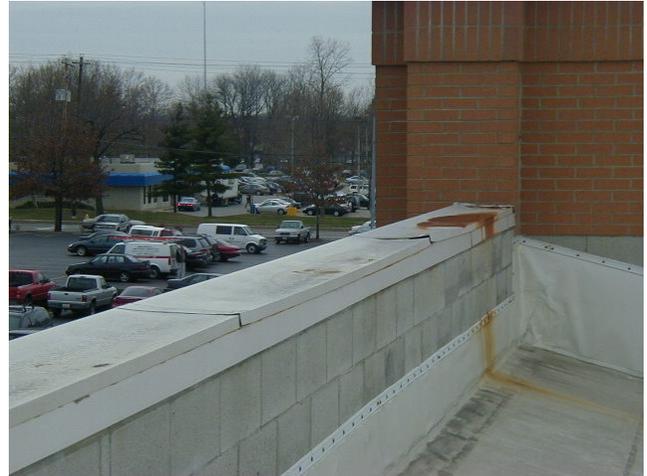
Parapet walls at the perimeter of buildings should always, without exception, be completely encapsulated or “wrapped” to use roofer slang. It is inevitable that when shortcuts are taken, as illustrated in the first two photos, that the walls will leak. These copings (copings are the metal caps on top of the walls) were never up to the task of keeping water out..and they didn't.

The exposed block wall in the first picture is definitely NOT what you want to see. The second photo shows the consequence. (The second photo shows the outside face of the wall that is shown in the first photo.) The arrow points to water stains on the face of the brick. Those stains have been caused by water entering through the back and top of the wall. The soffits (entrance canopy ceilings) below are damaged and the brick will be eventually fracture if this is not corrected.

The third photo shows the same area after it was repaired. In this case a piece of metal trim was installed at the outside edge. Another way to finish the wall is to install a metal coping across the top of the wall. Especially in single ply applications, encapsulating the walls should be considered a mandatory detail.
