Roof/Top/Topics

In This Issue...Paint and Waterproofing

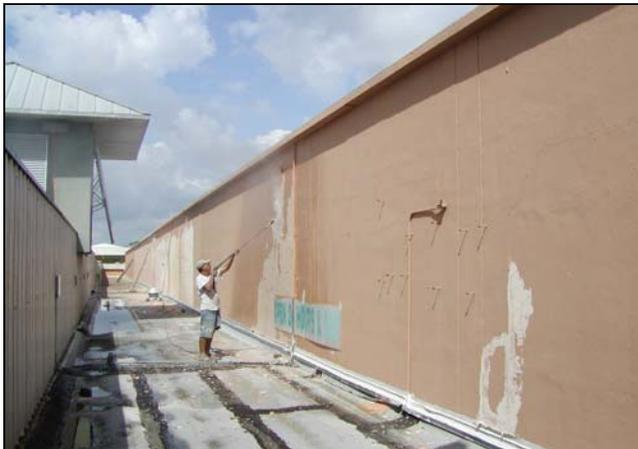
The front of this shopping center (below) had continual leaks right at the front wall. It was assumed that the roofs on either side of the wall were causing the leaks. (There is a second roof, out of view, at the top of the wall on the backside.) A visual inspection of the wall showed only a few minor cracks here and there, but not enough to account for the leaks. A painting contractor was contracted to water test the walls and the flashing points where the roofs terminated on the walls. He quickly discovered the problem. The paint had been improperly applied and had not bonded to the concrete. Water was passing through the paint and then sliding down into the building. Once the wall was cleaned, sealed, primed properly and then painted the leaks stopped.

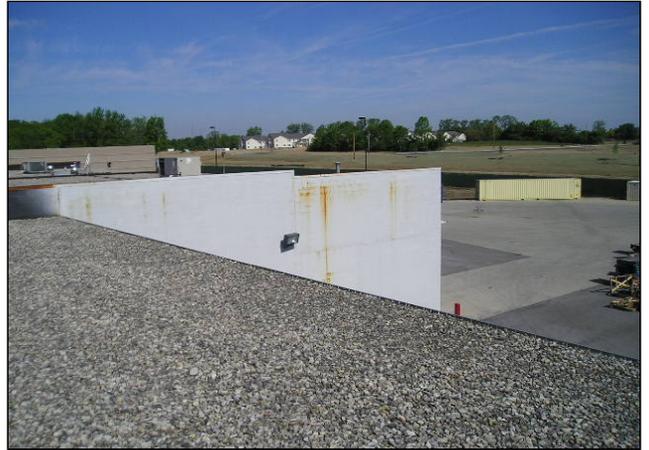
The staining on the side wall of this shopping center will necessitate the repainting of the wall. The cause of the stains is shown below.

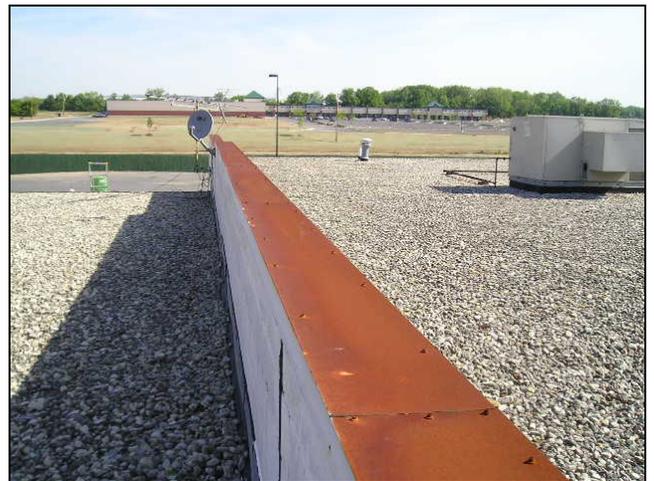
Field painted, galvanized copings will rust and if the tops are not properly treated the rust will roll over and stain the side of the building. We have even seen painters repaint stained walls and still not paint the tops of the rusted copings. It is not standard practice for painters to paint the horizontal surfaces on copings (or the outside lips of gutters). You must specifically require it or it will not normally be done. Failure to do so is almost always a mistake.
