Case Study 04...More of Roof Leaks That Weren't Roof Leaks

The Roof Leaks that Weren't Roof Leaks

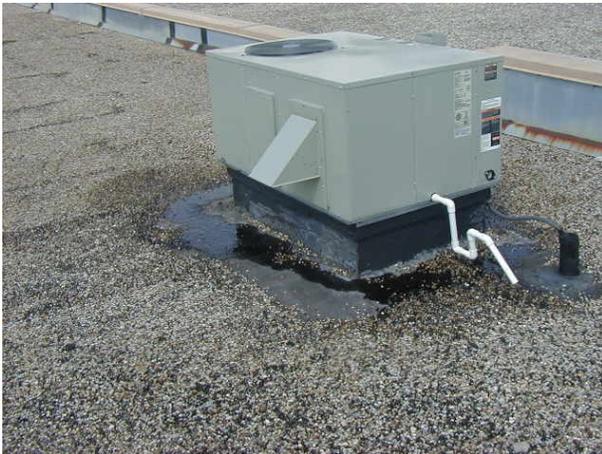
Judging by the various repairs at the base of the HVAC unit in the photo below, it looks like this unit has been leaking. Water has been coming in at the unit. There are times when the HVAC equipment itself will leak either because of defective manufacturing or because a condensate drain line is plugged. None of that has been occurring here. The repairs at the curb are watertight. That is not the source of the water.

The curb on this unit was designed to be insulated. It wasn't. You will notice that the top of the curb seems wider or thicker. That is the wood nailer to which you are supposed to fasten the roof flashing. Whoever flashed this curb just smeared roof cement on the curb as they tied it into the existing roof.

Since the curb isn't insulated it allows condensation to form on the inside of the assembly, which drips down into the building....leaks. How did this owner allow this to happen? Why did they have to get us involved in finding the problem?
